DIFFICULTIES WITH EXISTING FISH PASSES AND THEIR RENOVATION. THE POOL FISH PASS ON DŁUBNIA RIVER IN KRAKOW

The aim of study was to determine, how the pool fish pass located on the Dłubnia River operates and to formulate recommendations, due to which it will work effectively and will not be an obstacle for migrating fish.

Aim of the study is to assess the technical condition of a pool fish pass in a weir pillar on the Dłubnia River in Cracow. Research included field work, assessment of technical conditions in terms of possibility of fish migration through the aforementioned fish pass and the elaboration of recommendations for improving that will restore functionality of the structure.

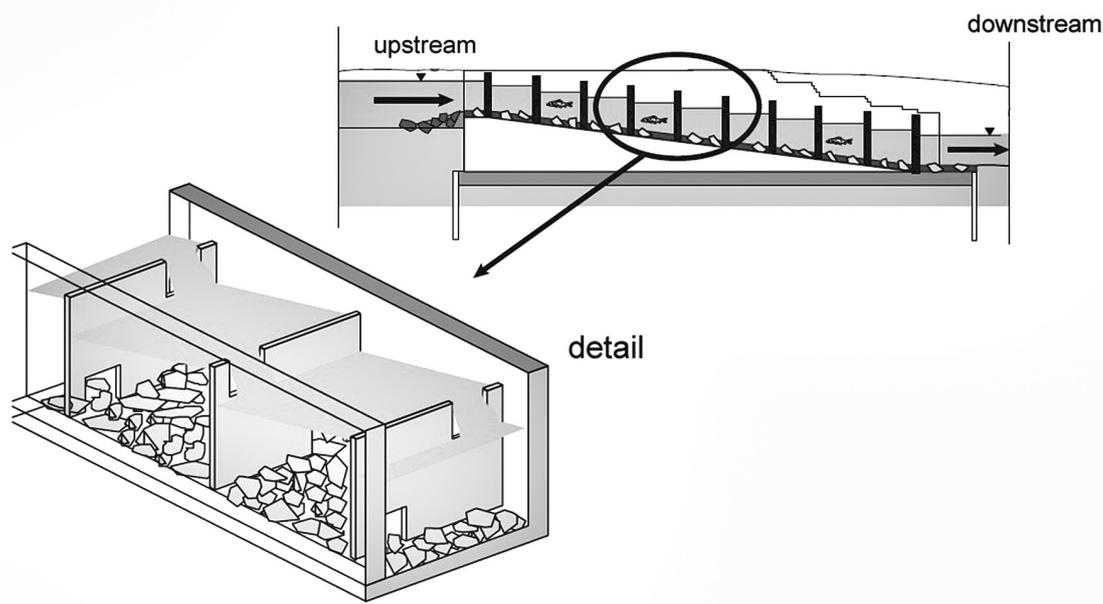
Fig. 1. Scheme of conventional pool fish pass (WWF 2016; Jens, 1982)

Inclination of bottom of a transitional bed usually varies within 1:4, and in a bed with increased roughness it is even 1:1.5 ÷ 1:1. With such relatively large slopes of longitudinal beds, velocity reduction is achieved by intersecting a flow gutter with transverse walls. Instead of cutting a gutter through an entire width, these walls could partition a gutter in such a way that fish move through existing slots without much effort. When a flow gutter is completely divided, fish may pass it either above the partitions or through the slots. This kind of fish pass is called stairway for fish, ladder type. Figure 1 shows an example of a pool

fish pass. The distance between the end of a compartment and the walls of a bed should not be less than 30 cm. Water depth should be approx. 50 cm. In Table 1 and 2 pools dimensions are presented according to fish species.

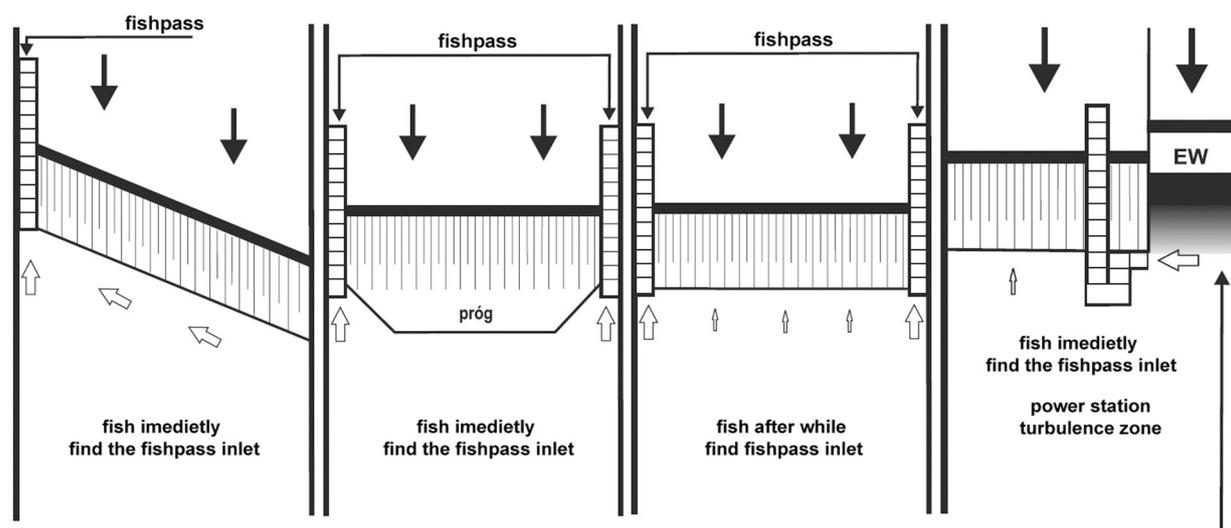
Fig. 2. Location of a fish pass outlet in relation to watercourse (Bojarski et al., 2005)

An important element that enables smooth operating of a fish pass is the location of an outlet, i.e. an entrance, which fish take travelling from the bottom to the upper station. Inlets and outlets should be mounted at least 0.5 m from water surface (fish pass is to operate during the highest and lowest water levels). Fig. 2 shows several location variants of an outlet of a fish pass. The best solution is when fish moving against the current can take a straight path, and the direction of a river coincides with the direction of an attracting stream (Bartnik et al., 2010).

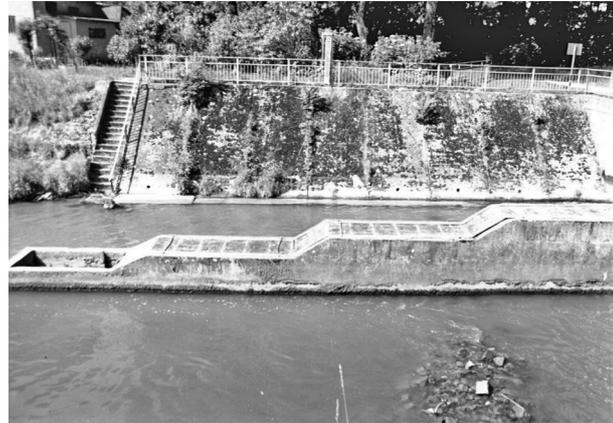
Fig. 3. Fish pass on Dłubnia River – longitudinal profile, side view (photo: A. Radecki-Pawlik)

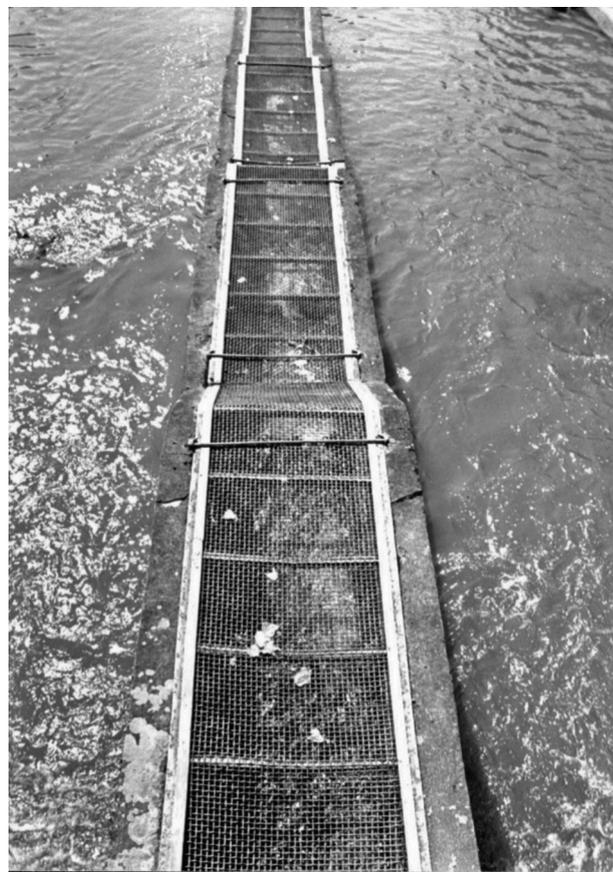
Fig. 4. Fish pass on Dłubnia River – top view (photo: A. Radecki-Pawlik)

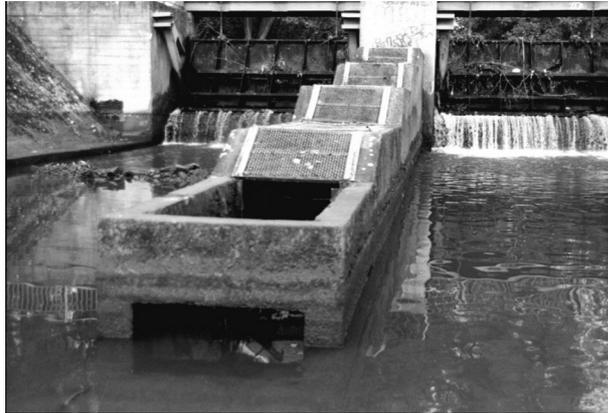
Fig. 5. Fish pass on Dłubnia River – view from downstream after draining the river channel (photo: G. Gajda)

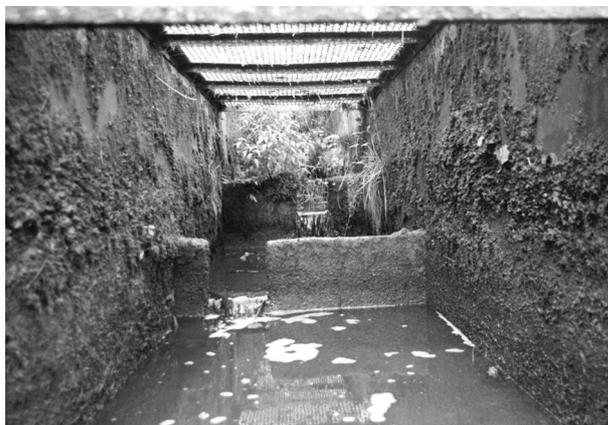
Fig. 6. Fish pass on Dłubnia River – inside view after draining the river channel (photo: G. Gajda)

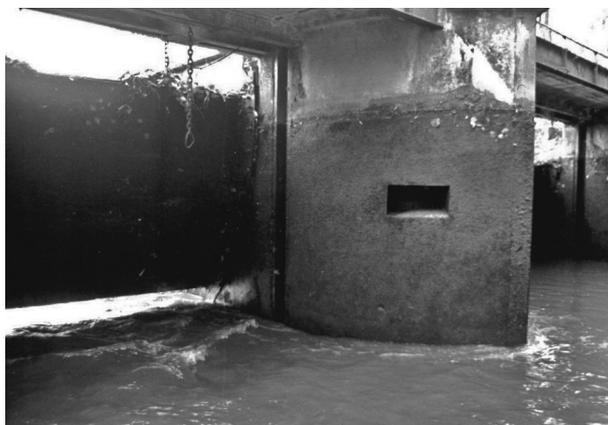
Fig 7. Fish pass on Dłubnia River – view of intake to fish pass through the river channel and the upstream reservoir (photo: G. Gajda)

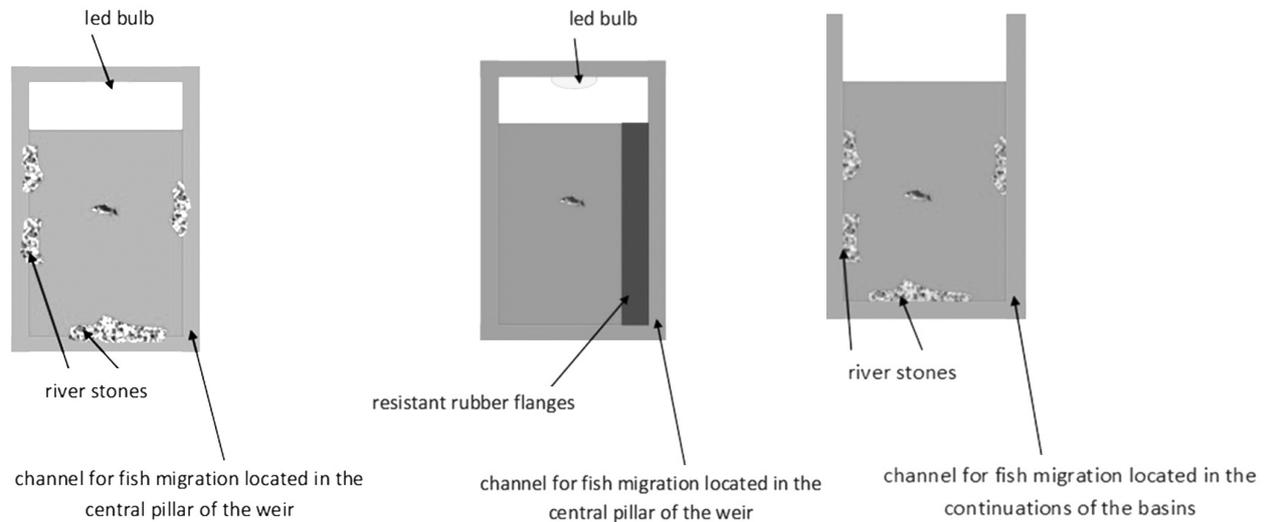
Fig. 8. Positioning of (a, c) river stones, (b) flanges and (a, b) led bulbs inside the channels of fish pass

Inlets to the fish pass are too small. Inside the middle pillar fish have no access to sunlight along a 4 m section, which can affect them negatively. To ensure an adequate flow in a fish pass and an appropriate brightness of an upper part of a fish pass (located in a weir's pillar), each slot should be 100×40 cm. If inclination remains the same in a new double channel in the middle pillar of the weir, river boulders should be placed to dissipate water energy (see: Fig. 8a, c). Another way to dissipate energy includes rubber flanges, which should be attached to vertical walls at entire height in both channels (see: Fig. 8b). Both should be arranged alternately. In order to light up the channel, waterproof LED bulbs with a power of 14 W should be mounted onto the ceiling (see: Fig. 8a, b). These bulbs must operate continuously.

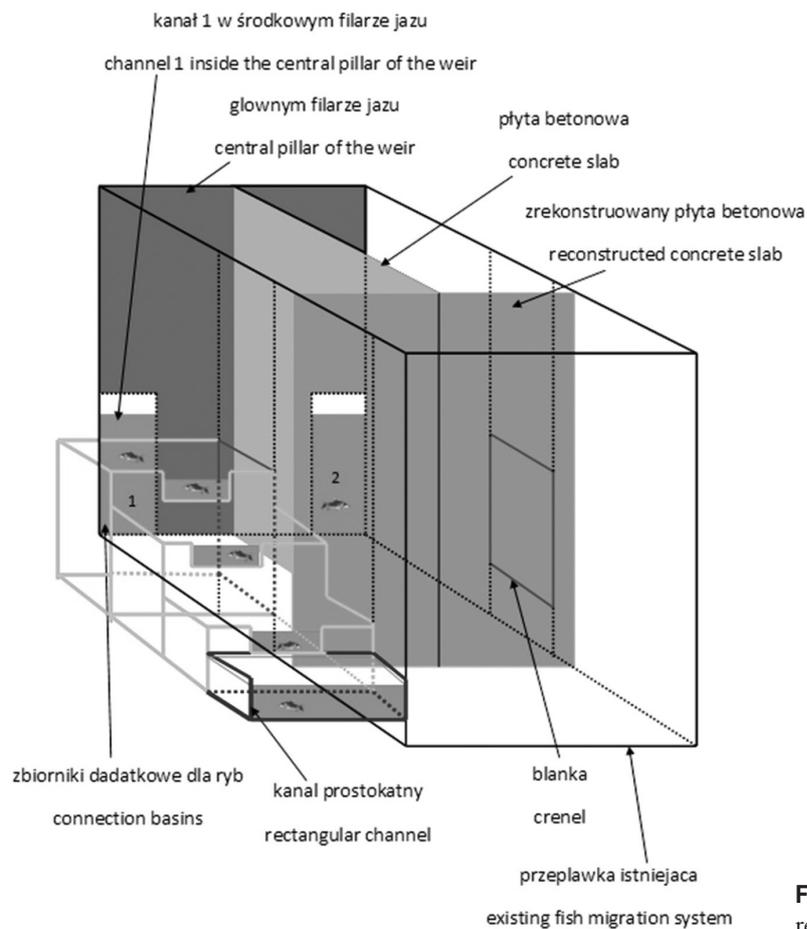
Fig. 9. Positioning of connection basins and rectangular basin for fish migration

At the bottom outlet of the middle pillar of the weir, two existing channels should be separated by a 0.10 m high concrete barrier (see: Fig. 9). Two channels will be subsequently attached to the outer walls of the old fish pass with metal stilts, thus creating 3 pools with a length of 15 m (see: Fig. 9). The pools will be made of 0.10 m thick concrete. The first pool will have a depth of 1.50 m, the second – 1.35 m, and the third – 1.20 m. The width of all pools will be the same – 1.00 m. A rectangular channel with a height of 1.05 m, also made of 0.10 m thick concrete, will be attached to the last pool. This channel will also be connected to the existing fish pass. The pools will also be fixed into riverbed by stainless steel rods with a diameter of 10 cm. New positioning of the pools reduces drop gradient, which facilitates the passage for fish. Rectangular channel will be about 10 m long with a pool located in the middle. The resting pool will be 1.00 m long, 0.45 m wide and 0.40 m high.

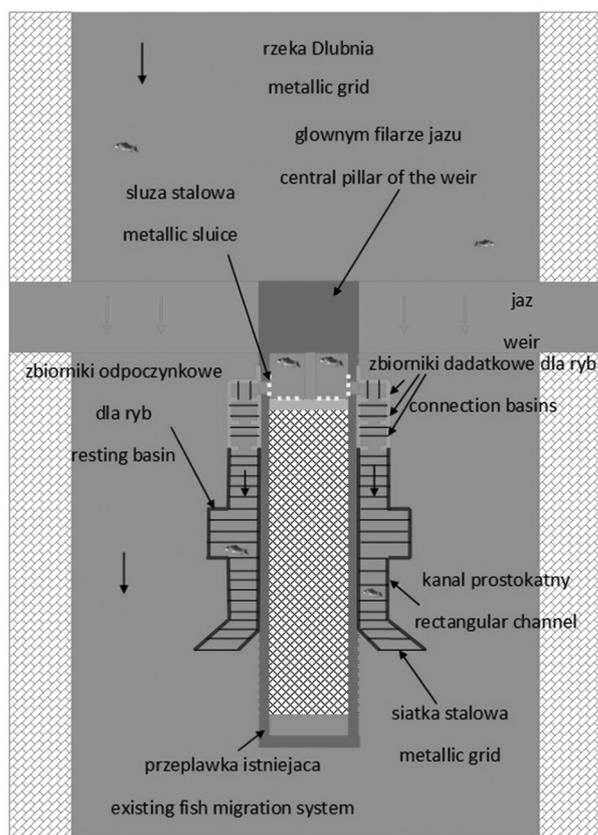
Fig. 10. Positioning of the two symmetrical fish migration systems

In the new system, there are two symmetrical channels for fish migration with the same dimensions as the existing fish pass (see: Fig. 10). All pools will have metal grids placed at the top of the system to avoid poaching. These gratings will be fixed into metal frames that will have hinges, which will allow them to be opened in case of required repair.

Two symmetrical systems with the same dimensions and properties, which are well set, do not support large damages during floods, can be relatively easily repaired, and due to design and materials used have a long preservation span.
