Hop River

Hop River was ecologically restored by Bioengineering Group, MA on a portion of about 400 meters both on the left and on the right banks. Banks have been stabilized by vegetation and coconut rolls situated on three lines as in (fig.1).

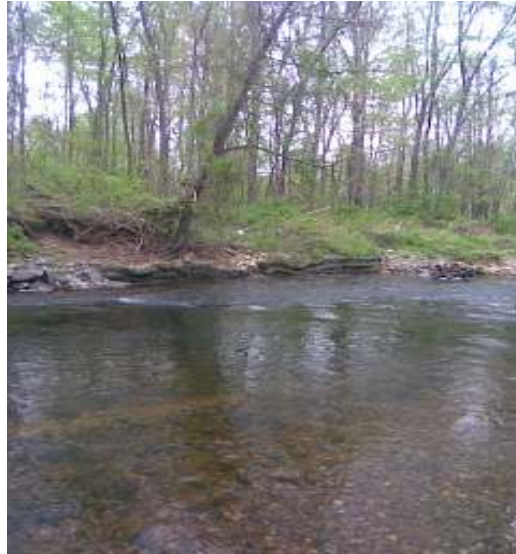
Fig.1 Development of the Hop River's left bank

Sandy banks of this river cannot give it a stable fixation if they are stabilized only at the base area, therefore scattered planting of trees as was done in the previous project are needed. What has been achieved until now regarding this project was done correctly, although nobody really knew about the sandy composition of these banks. Therefore, the banks were destroyed and they covered a large part of the coconut rolls arranged on three lines which required a different ecotechnical stabilization of Hop river water course(fig. 2).

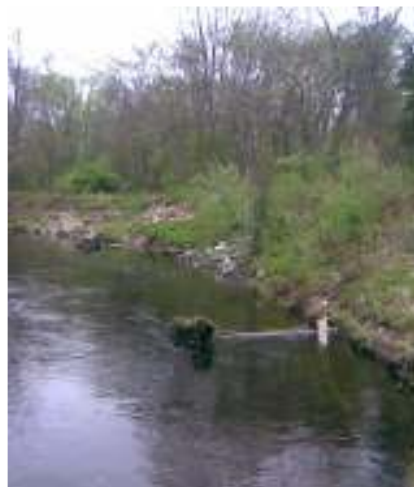
Fig. 2 Development of the Hop River's right bank

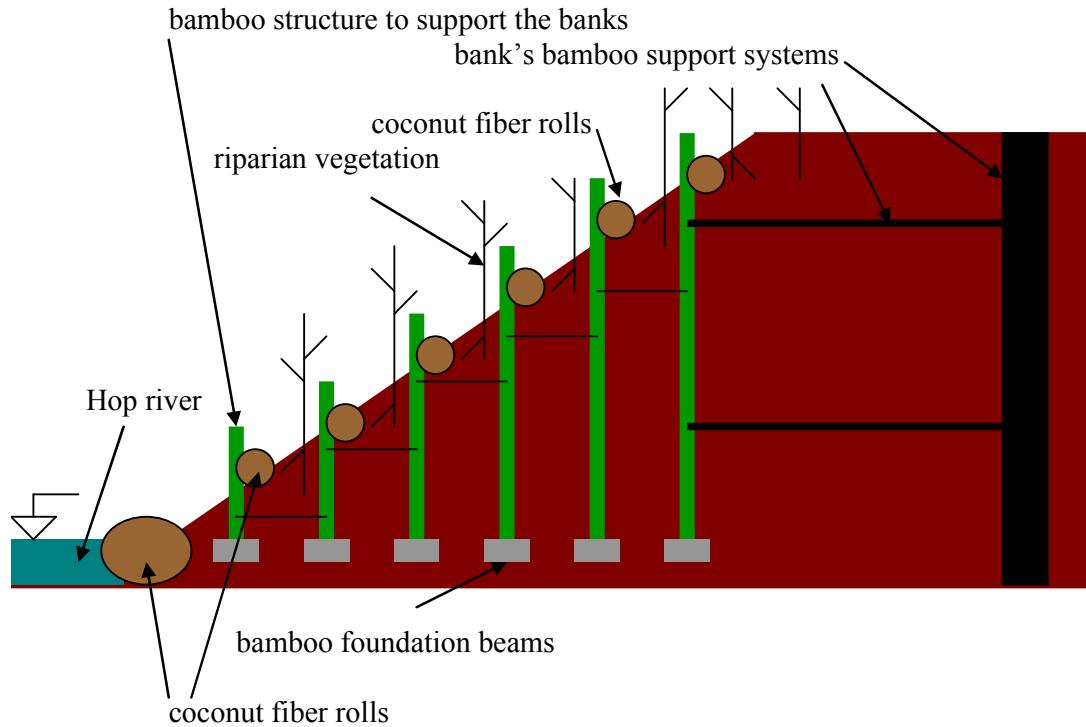
Banks which were restored in the past must be restored ecotechnically once again using the bamboo structure pillars method. First, the bank should be drilled on several lines, then bars or rods of bamboo are to be fixed inside. A structure like a strong and flexible wooden and, in the same time, unpollutant framework (fig.3) must be formed. Bamboo rods can form a structure capable to take over the tangential and longitudinal efforts of the floods.

Fig.3 Ecotechnical development of Hop River's right bank - indicative schedule

Sectors of bamboo beams that come out of the ground support, on a side, the coconut fiber rolls and, on the other side, they support riparian vegetation planted in line on the entire length of the study sector (fig.3). Besides banks supporting, coconut fiber rolls stop fine particles of ground from sliding towards the Hop river water and redirect storm water to the edges of the studied sector exactly like drains.(fig.4).

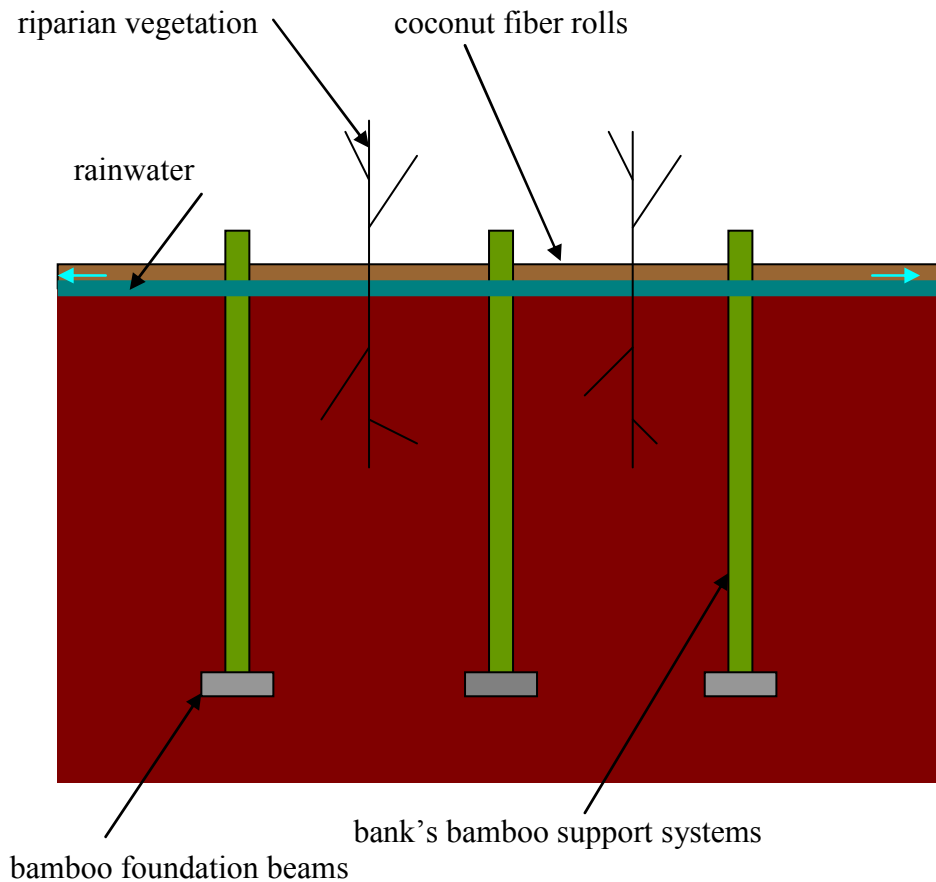
Fig. 4 Functional aspect of coconut fiber rolls – indicative schedule

Also, the coconut fiber rolls absorb and a large amount of polluted organic substances coming from the slopes resulting into a useful stopping of waterways pollution. Local riparian herbaceous and woody vegetation planted in order to sustain the banks (fig.4) has great possibilities of development and normal living due to the bamboo support system and coconut fiber rolls.

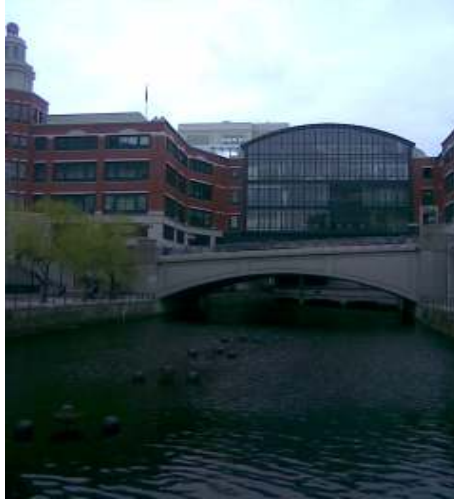
A totally concreting of this river has led to an acute pollution and destruction of the lotic biodiversity almost entirely(fig.1).

Fig. 1 Providence river

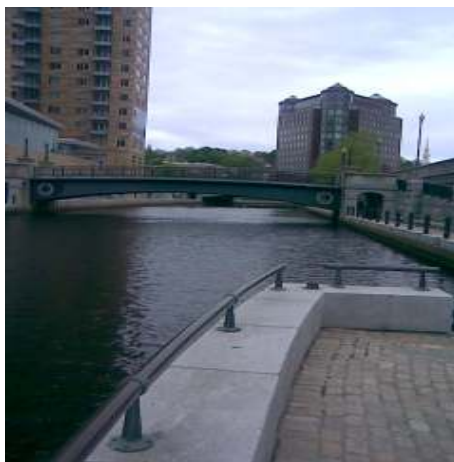
Fig. 2 Providence river

For a portion of several hundred meters to the first bridge (fig.2) Providence River may be ecologically restored by building a white rectangular meander bed endowed with a herbaceous and woody riparian zone(fig.3).

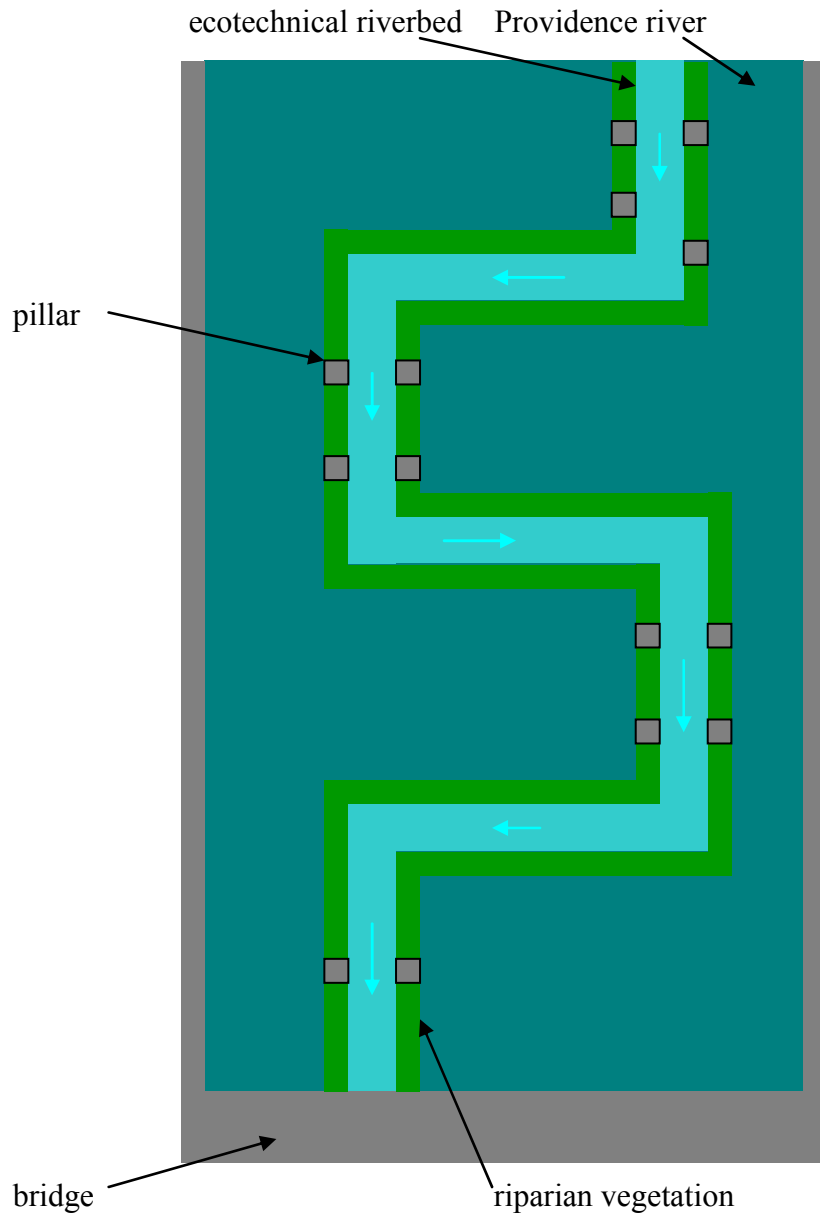
Fig. 3 Riverbed meander - indicative schedule

This rectangular bed should be made of treated bamboo for not being eroded by water. Water on this a river bed comes from Providence River by collecting water from upstream sector which is to be ecotechnically rebuilt (fig 4).

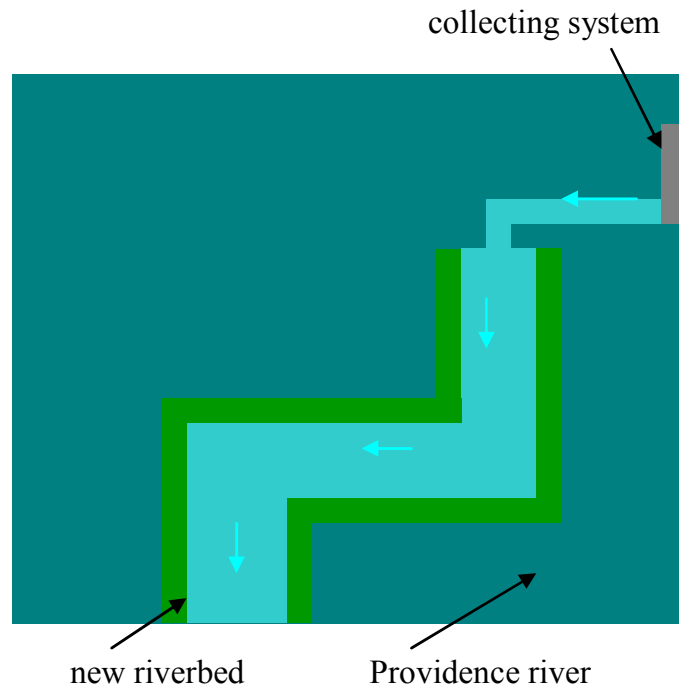
Fig.4 Collecting water - indicative schedule

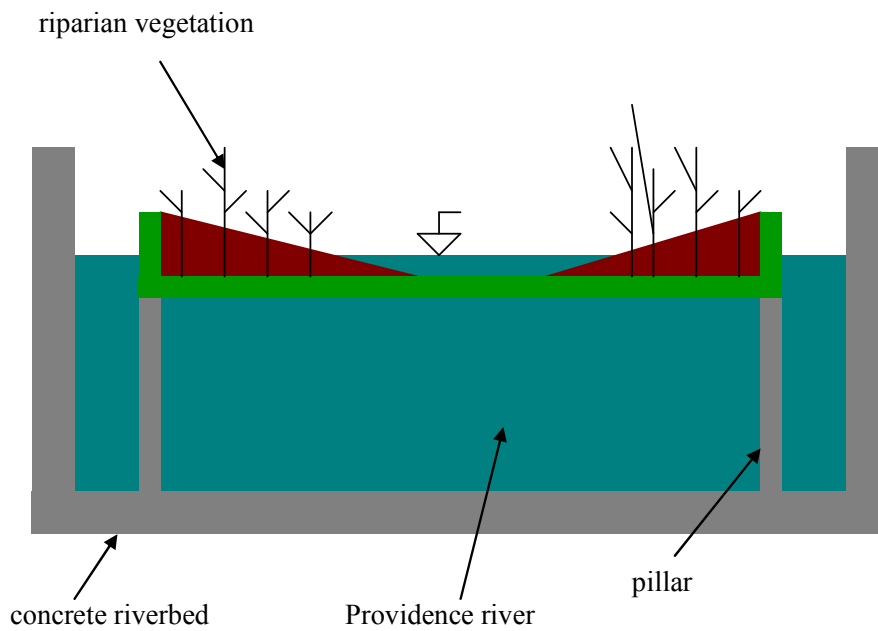
Riverbed establishment will be made using pillars fixed into the riverbed. (fig.5).

Fig. 5 The new riverbed - indicative schedule
