IMPROVING UPSTREAM AND DOWNSTREAM FISH PASSAGE AT RETIS DAM ON HÂRTIBACIU RIVER - SIBIU COUNTY (TRANSYLVANIA)

Răzvan Voicu¹, Pete Baki²

Keywords: fish migration, ecobiome's functionality, Hârtibaciu River, fish passage dam.

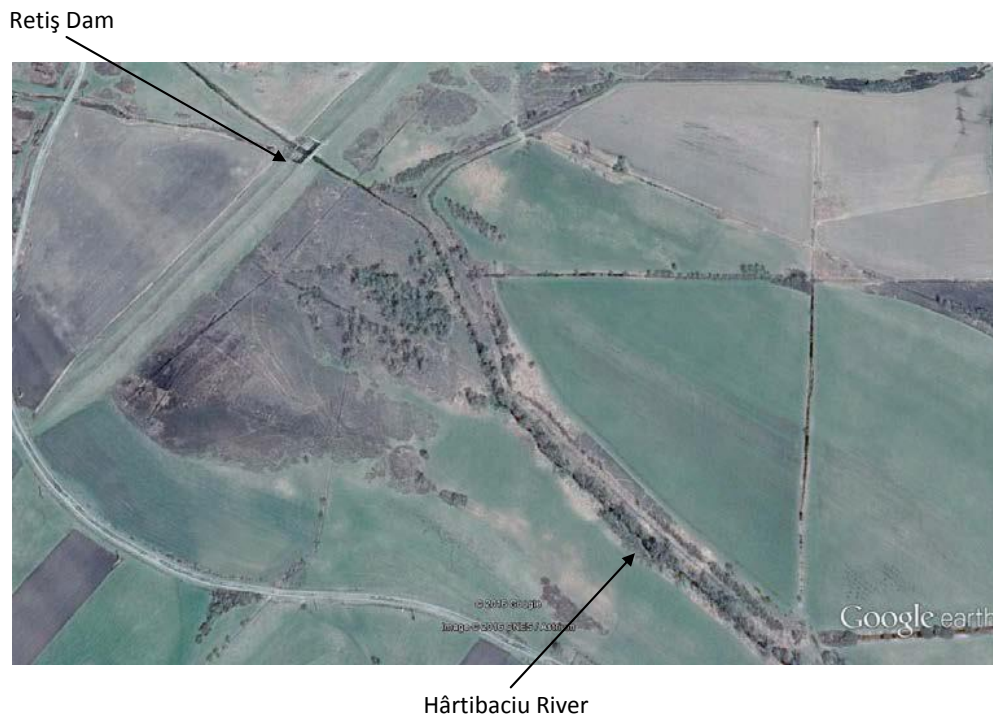
Figure 1a. Retiș Dam located on the Hârtibaciu River (google earth.com)

The Hârtibaciu River is largely managed and diverted for agricultural use (Figure 1a). At the Retiș Dam, infrastructure includes a breach (D1, Figure 1b, 1c) through which the Hârtibaciu River flows and a 20 cm-thick concrete pier set in the middle of the spillway. This concrete pier fits the breach both horizontally and obliquely.

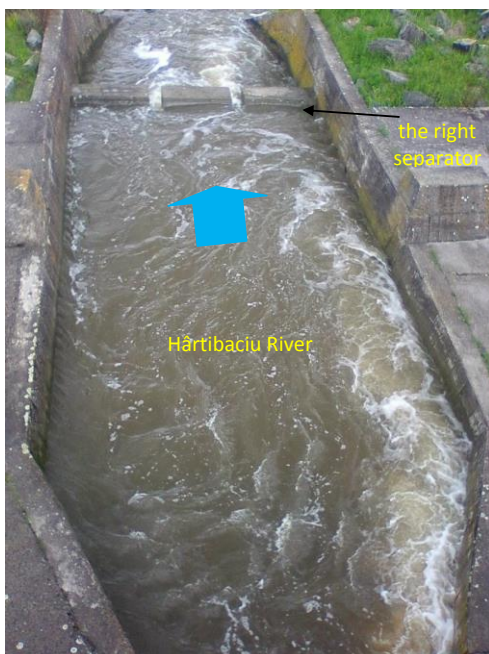
Figure 5 a The location of the right separator

About 14 m distance after leaving the breach, this concrete ramp will pass tangentially to the right separator that is fixed into the concrete right bank (Figure 5a and Figure 5b).
