FISH MIGRATION SYSTEM OVER A WOODEN DISCHARGE SILL LOCATED ON THE BISTRA MĂRULUI RIVER

Keywords: fish migration, lotic ecosystem, Bistra Mărului River, fish passage, discharge sill.

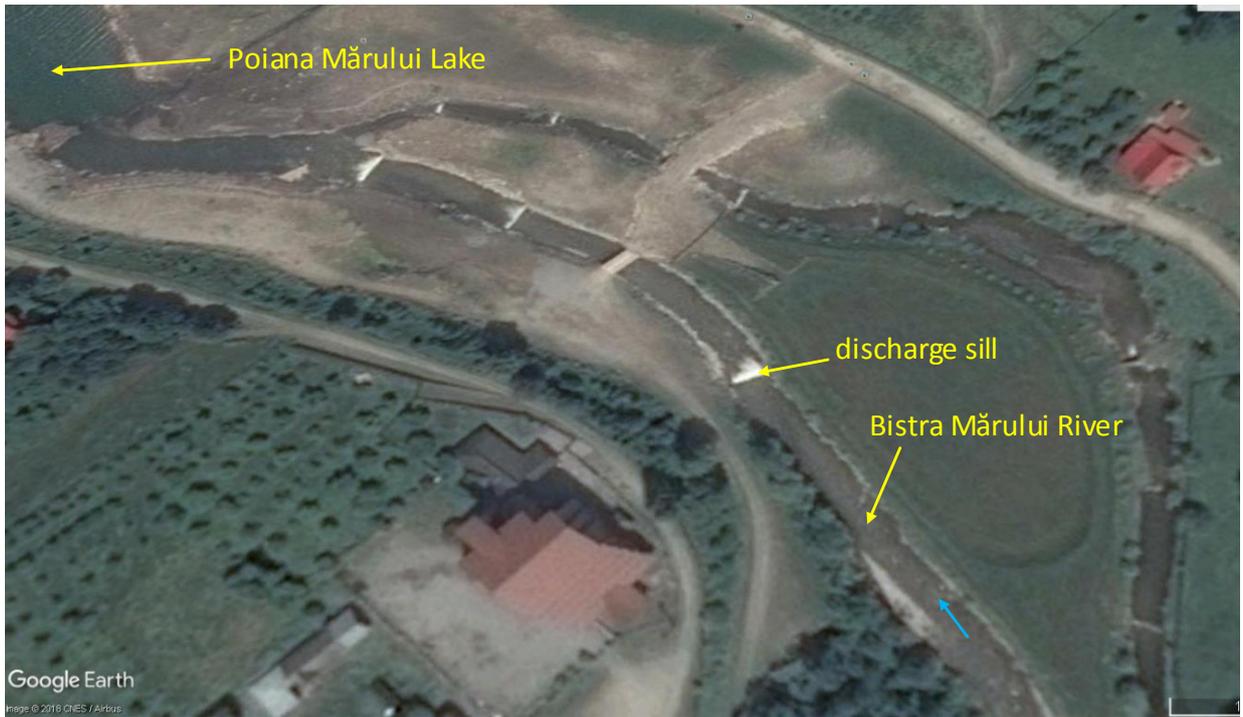
Figure 1a. Discharge sill located on the Bistra Mărului River (google earth.com)

The over 12 discharge sills on the Bistra Mărului River and its tributaries block both migratory and non-migratory species. On the Bistra Mărului River there are several discharge sills made of wood materials (figure. 1a). One of them is made of a tree with a diameter of 1,2m fixed in the banks of the river (figure 1b). The fall of water is slightly more than 1 m, which completely blocks any migratory species of fish on the Bistra Mărului river. The length of the spill threshold is 8 meters. The Bistra Mărului River is located in the Timiș river basin. The length of the Bistra Mărului River is about 34 km, the surface of the river basin is about 291 km² and the multiannual average flow is about 2 m³/s.

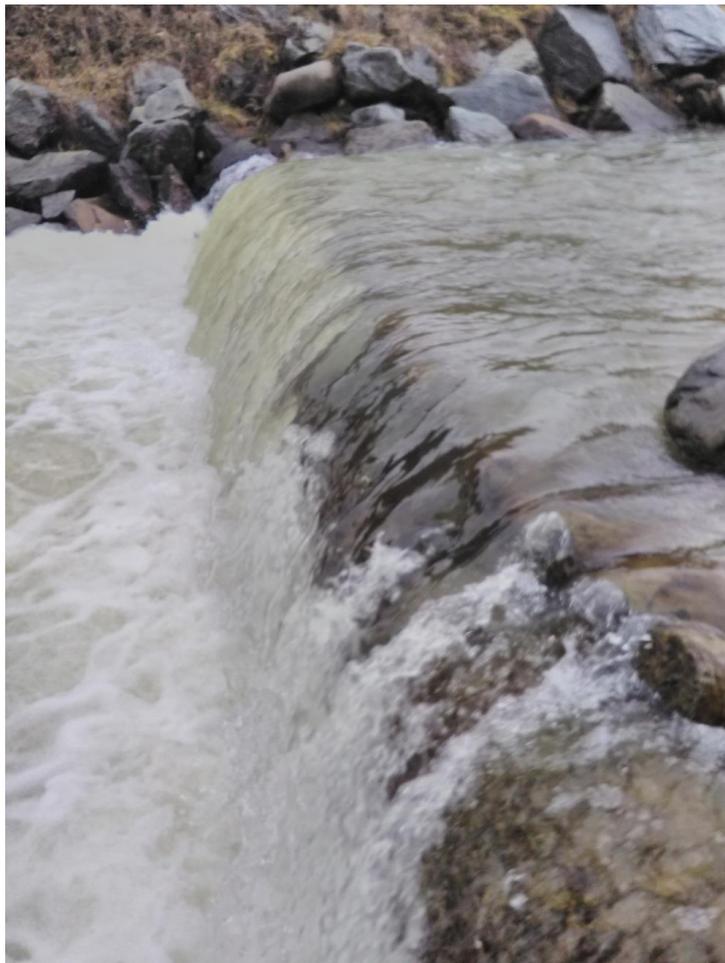
Figure 1b The discharge sill made from a tree

Fixed on the discharge sill are wooden bars that have the role of dissipaters (figure 1b). On the discharge sill (shaft), a crenel of 40cm wide and 60cm length will be made. The upper edges of the crenellate remain semi-circular (figure 2).

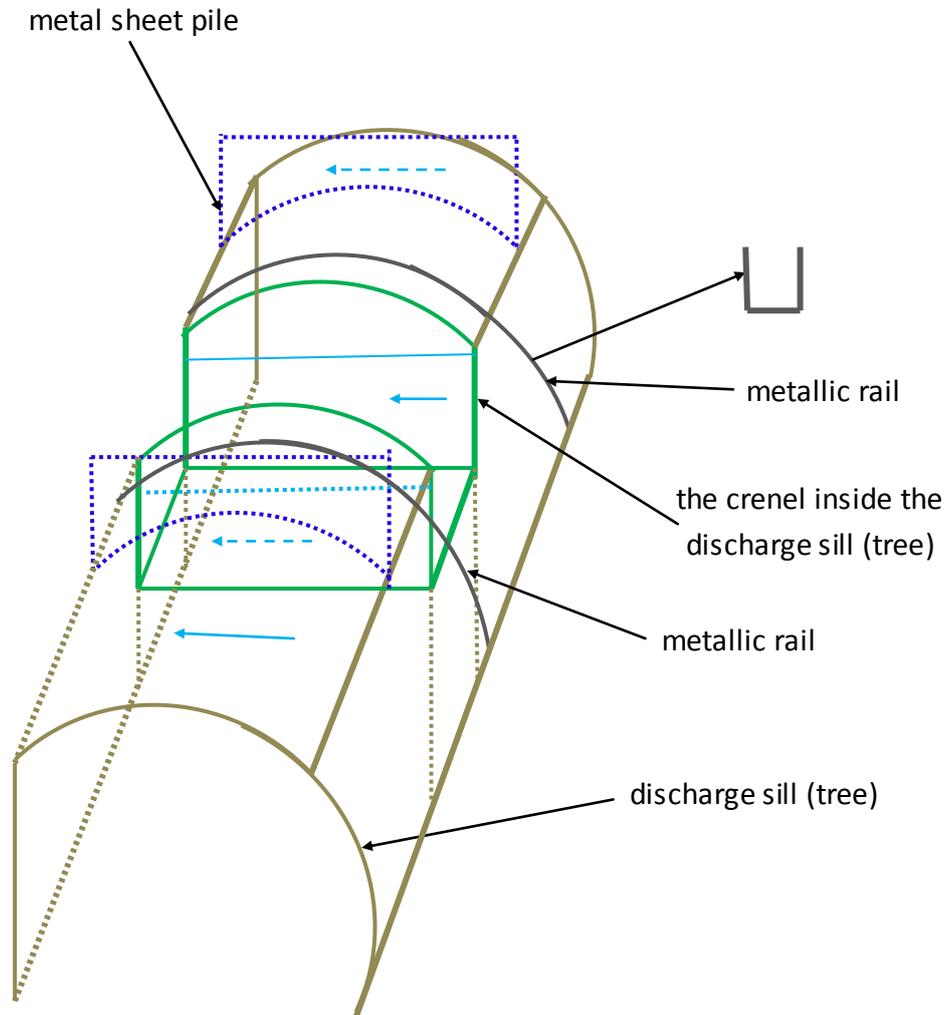
On both sides of the discharge sill crenel, two U-shaped metal rails will be attached between the two metal sheet piles (figure 2). A metal frame is formed which supports two bearings. There are two such metal frames. The bearings are fixed to resilient rubber separators and not to slip sideways (the bearings must run linearly) on the U-shaped rails. Before the bearings, a metal frame is inserted into the metallic space (U) (figure 3). Two such metal frames will be fixed to the bearings. On the vertical bars belonging to the metal frame with two bearings are fixed two very hard metal springs (figure 3). After the bearings are fixed inside the U-rails, a metal cornice for each rail (figure. 3) is fastened on both U-bars. These metal studs have a tapered stopper on the top to prevent the bearing from moving vertically more than 1 mm. The same thing happened with the side stops that do not allow the bearing to move horizontally more than 1 mm on both sides. The metal frame made of bearings and metal bars welds a semicircular metal sheet pile. This metal sheet pile perfectly closes the crenel in the tree, that is, the discharge sill, when it is in the initial position. The metal frame as well as the pylon moves on the metal rails. Two metal handles that penetrate through the semicircular metal sheet (figure. 3) are welded to the metallic frame. These handles allow the system to move from the initial position to the final position.

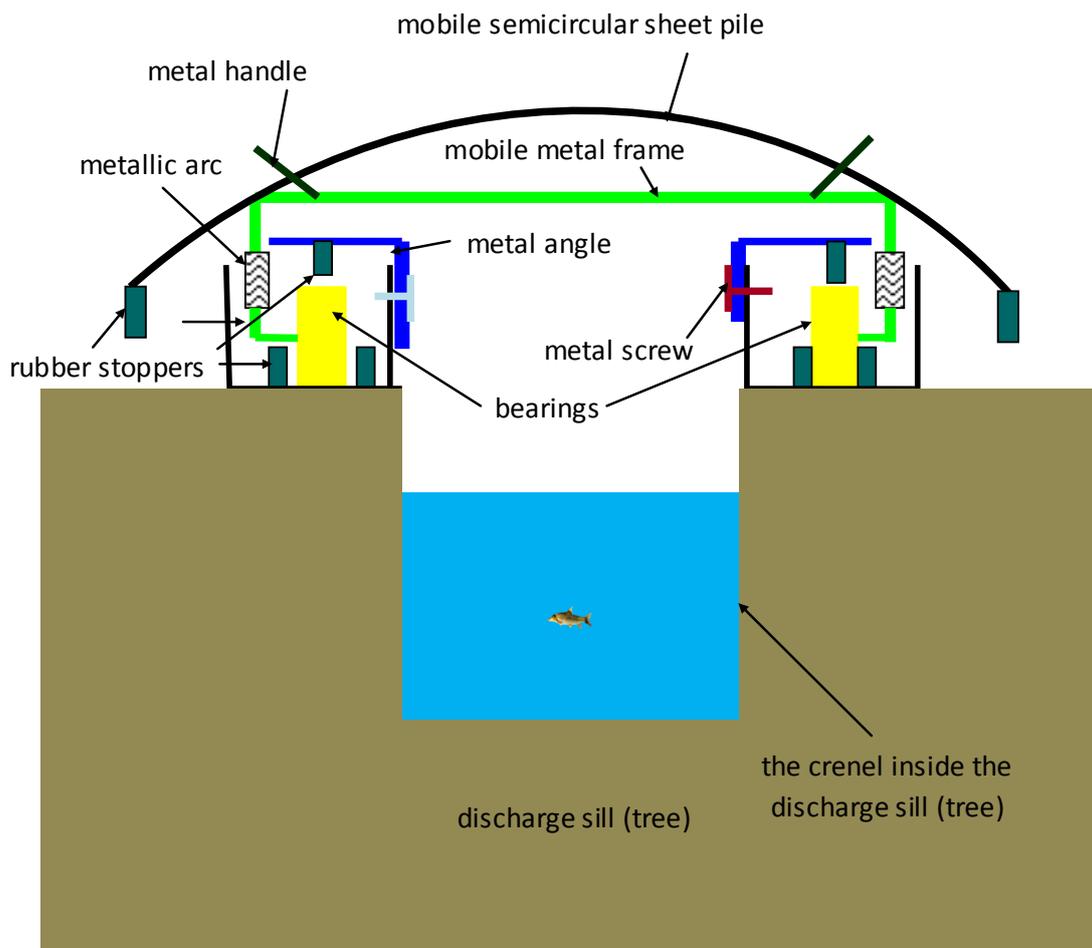
Figure 3 Positioning of the mobile system (metal frame and semicircular sheet pile) - indicative scheme

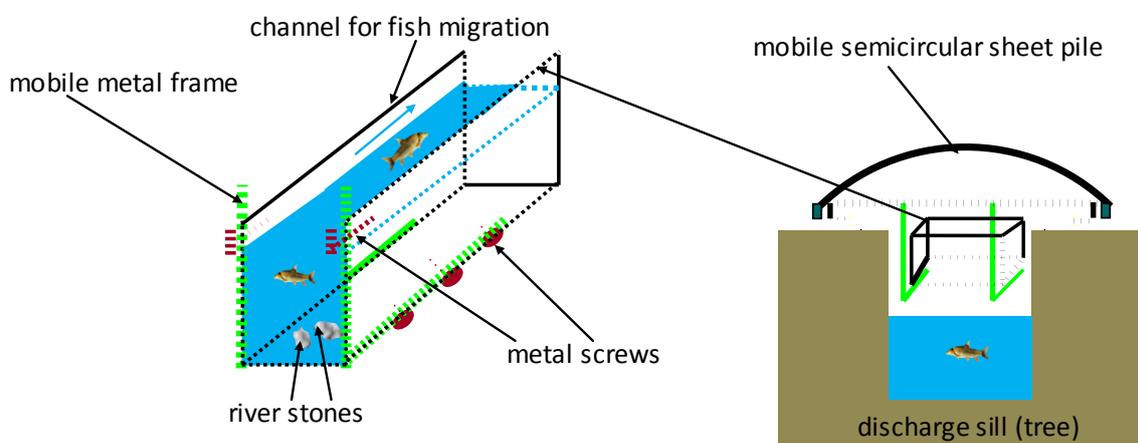
Two metal bars in the form of a rectangular parallelepiped are welded to the metallic frame. From these metal bars, a rigid plastic palpation channel or non-corrosive metal can be attached to the fish migration. This channel has the size of the crenel in the spill threshold and has the same slope with it (figure 4). On the horizontal surface of the channel for the migration of the fish, there are fixed river rocks as dissipaters (fig.4). The fish migration channel is fixed to the metal bars by means of the metal screws (figure 4). Bars welded by the mobile metal frame and fish migration channel weigh more and keep the system in the final position that allows the fish to migrate upstream - downstream of the spillway. The river's depth of about one meter in the immediate vicinity of the spillway, upstream and downstream of it, allows the stationing and work of specialist personnel in the riverbed so that the system can be assembled or disassembled.

Figure 4 Positioning the Fish Migration Channel - Indicative Diagram or scheme
